BRAKE DISCS

BRAKE DRUMS

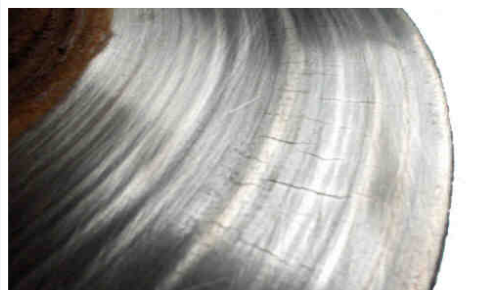
WEAR

The minimum disc thickness is stamped on the outer diameter of the brake disc. The minimum thickness is the measurement across the width of the worn braking faces. If the thickness is below the advised minimum size, the disc must be replaced. The disc should also be inspected to see if it is wearing equally on both faces. If there are any signs of uneven wear then the caliper should be inspected to ensure correct operation and re-set as per the manufacturer's specifications. If there is excessive wear across an axle then it is recommended that the distribution of the braking load between truck / trailer and other axles is checked.

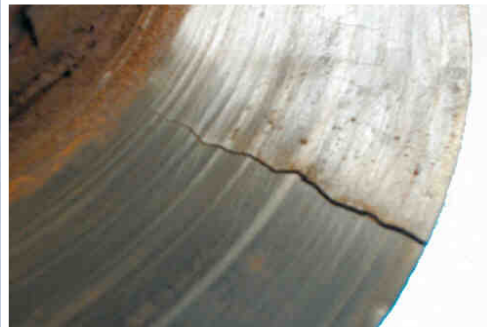
HEAT CRAZING

Heat crazing, as illustrated, is the result of normal heating and cooling of the brake disc during service. These fine heat cracks are not detrimental to the performance of the brake. However, heat crazing can develop into deeper cracks. Therefore, any discs with radial cracks deeper or wider than 1.5 mm should be machined, as long as the minimum thickness allows, or replaced. The early development of heat crazing can be an indication of an operational problem.

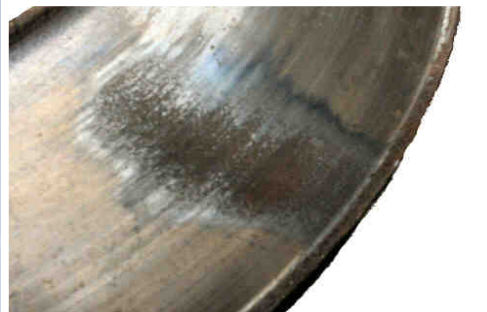
CRACKING

Deep surface cracks, as illustrated, is usually the result of excessive heat. Brake discs with cracks going through to the cooling duct or from the inner to outer edge of the braking face must be replaced. Once the disc has been replaced the braking system should be checked for correct caliper operation and balance between wheels, axles and trailer.

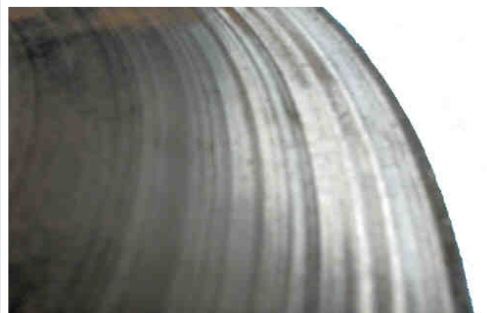
HARD SPOTS

Hard spots are slightly raised coloured areas on the braking surface and are created by non-uniform contact cycles creating localised graphite crystallisation in the surface of the cast iron. It may be possible to remove these hard spots by skimming the braking surface if the disc is within the minimum allowable thickness. However, continuation of this condition can, under extreme conditions, result in a thermal transformation of the casting structure into a material known as "martensite". Martensite is an extremely hard material which cannot be removed, therefore we would recommend immediate replacement.

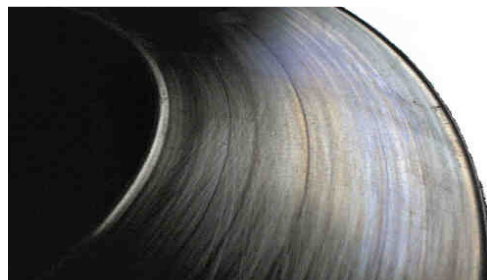
GROOVED DISCS

A grooved disc is defined by circumferential scoring around the braking surface. If the depth of the grooves exceed 0.5 mm (0.020") then the brake disc must be either machined, if the minimum thickness allows, or replaced. We would also recommend that the brake pads are inspected and replaced if the wear pattern has transferred to the friction surface.

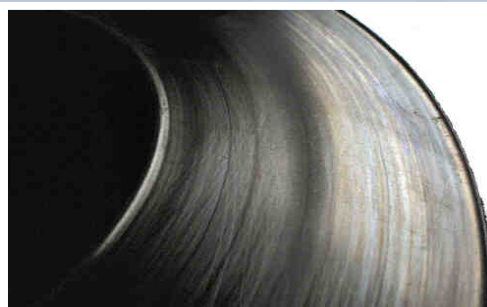
BLUE COLOURING

The blueing of the braking surfaces indicates a high operating temperature. This can be caused by continued hard stops, an imbalance in braking or a malfunction in the brake caliper. It is not necessary to machine or replace the brake disc but the braking system and caliper adjustment should be checked.

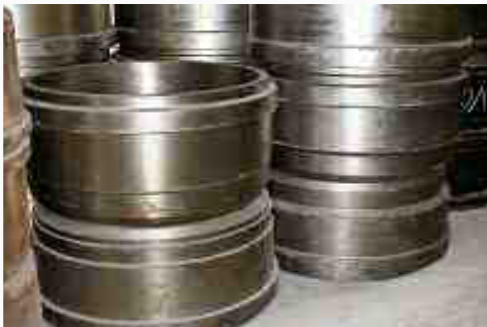
OVALITY

Brake drum ovality is a condition where the drum is out of round. The maximum tolerance we allow for ovality is 0.005" (0.127 mm). Ovality is usually caused by improper handling but can also be affected by incorrect storage or extreme operating conditions. Therefore, brake drums should always be handled with care and stacked correctly (see storage image below). It may be possible to re-machine the braking diameter as long as it does not exceed the drums allowable limitations.

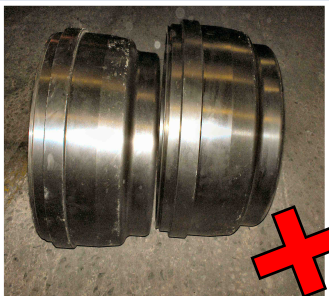
STORAGE

We would always recommend that brake drums are stacked face to face starting with the open end on the floor, as illustrated in the left image. Incorrect storage, as illustrated on the right images, can cause operational issues including ovality. Brake drums should always be handled with care and assistance sought for heavier items.
