WINNARD

TECHNICAL BULLETIN HUBKIT INSTALLATION OBSERVATION

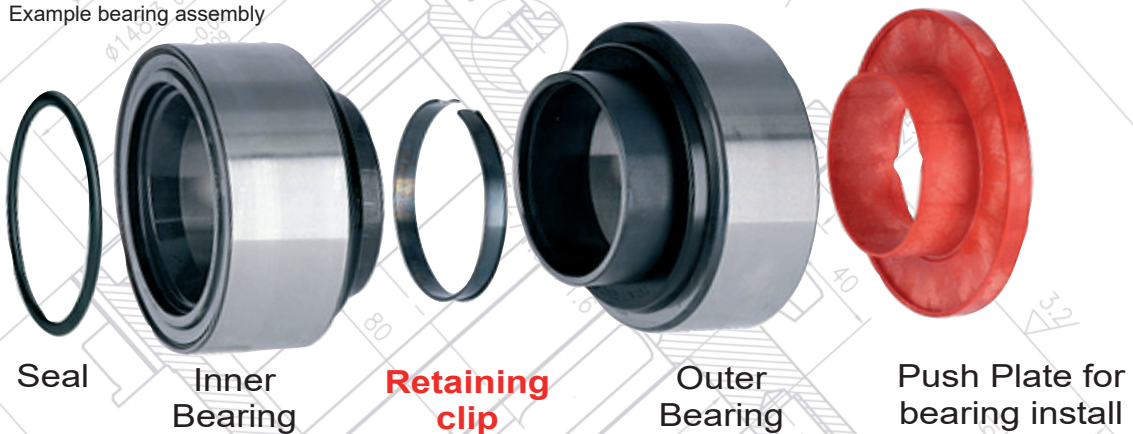
Example bearing assembly

When installing HUBKITS it is vital **not** to damage or dislodge the central retaining clip in the bearing.

Due to the weight of the part, care should be taken to ensure the HUBKIT slides onto the stub axle without catching the central retaining clip.

Placing excessive load on one side of the bearing can also dislodge the clip. Any movement or damage to this clip can cause operational failure.

A dislodged clip can be re-fitted, but you **MUST** ensure the clip is seated correctly and holding both bearings flush.

If in doubt contact our technical department for guidance.

To help reduce the possibility of damaging the clip we recommend that heavy handling equipment is used or a two man lift system adopted.
