TECHNICAL BULLETIN

SCANIA BRAKE DRUM SC1021 DESIGN CHANGE

Original Equipment Part Numbers: 1361331, 1414153, 2109552, 2378715, 324878, 360571, 368269, 392386

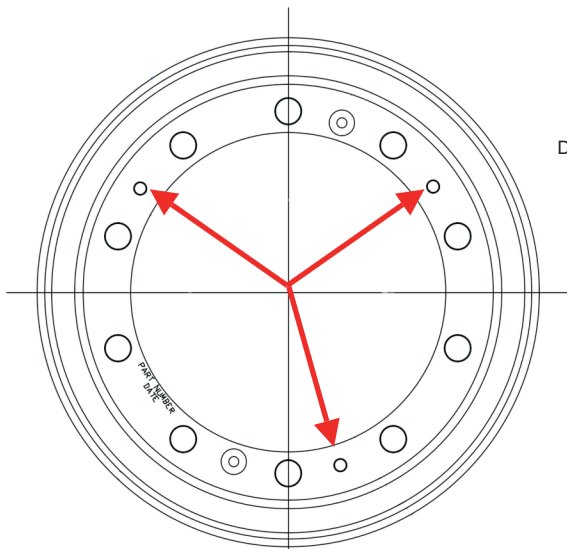
OLD DRILLING POSITION

The three M12x1.75 threaded holes used to remove the brake drum from the hub have changed position.

SC1021
DRILLING PLAN VIEW

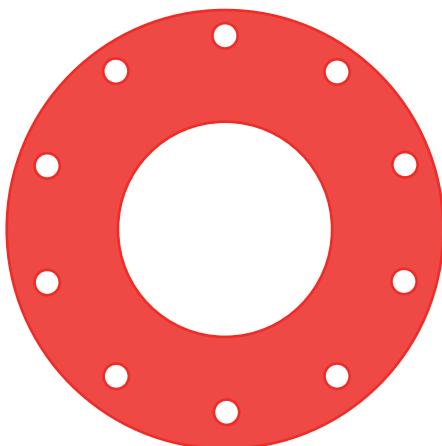
OLD HUB

SCANIA HUB DESIGN
ILLUSTRATION

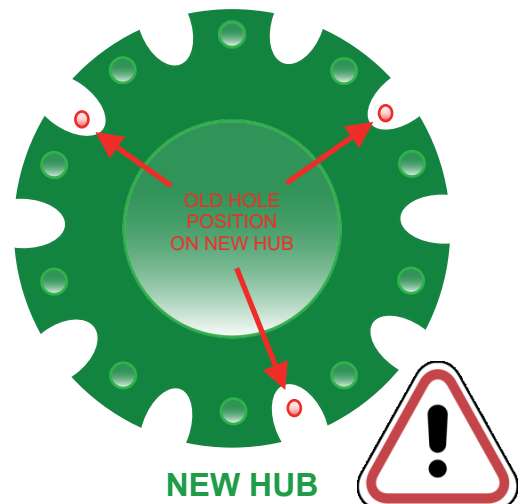
NEW HUB

New hub design means that the central threaded holes would NOT engage with the hub when being removed.
