## FAG Service Info

# Installation instructions for FAG 201050 / 632203.H195

## Check the protective rings behind the wheel hub

Models: Actros M P2 / M  
P3 Antos  
Atego / Atego 2 / Atego 3  
Axor / Axor 2

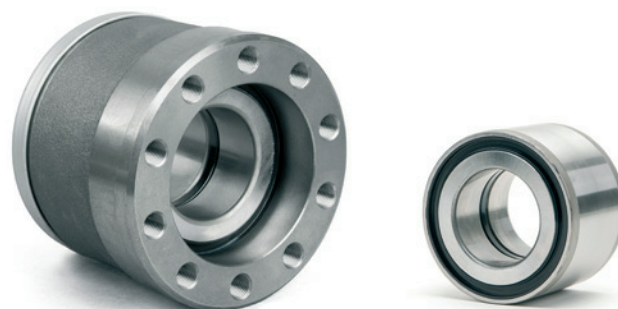
Image 1: FAG wheel bearing unit (TAM) – part no.: 632203.H195 (left), FAG wheel bearing – part no.: 201050 (right)

Schaeffler Automotive Aftermarket offers both the individual wheel bearing and the complete wheel bearing unit (TAM) for the vehicles listed above. This consists of a wheel bearing housing, wheel bearing and ABS sensor ring.

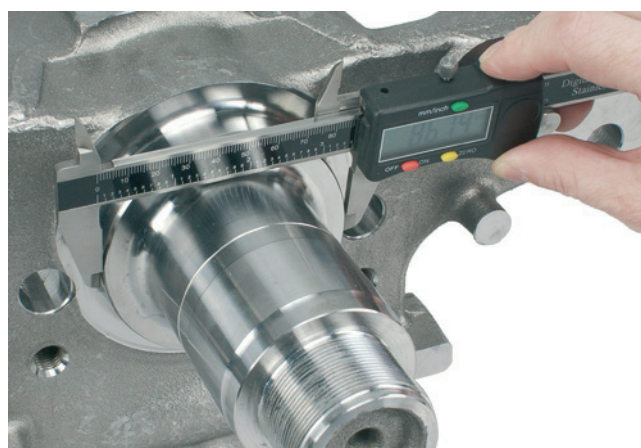
When identifying the part, please note that there are three different variants. To identify the correct protective ring, the diameter of the sealing seat must be measured.

Measured diameter	Protective ring required	OE-Part no.
86,70 to 86,85 mm	with no coloured marking	A 970 997 03 46
86,85 to 87,05 mm	with red marking	A 970 997 09 46
87,05 to 87,30 mm	with white marking	A 970 997 10 46

Figure 2: To determine which of the three protective rings needs to be installed, the diameter of the sealing seat must be measured

If it is found during the repair that the protective ring behind the wheel hub is defective, the protective ring must be replaced. One way of ordering a replacement is based on the vehicle manufacturer.

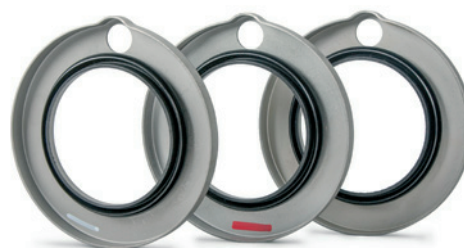
Image 3: The protective rings have different inner diameters.
