FAG Service Info

803750.10.H195

Supplied ABS ring must be used

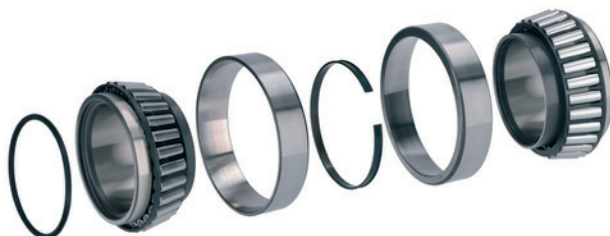
Image 2: Insert Unit

In most cases, an insert unit is installed ex works for the vehicle or axle manufacturers listed above. FAG offers the Repair Insert Unit (RIU), part number 803750.10.H195, as a repair solution.

The RIU is a pre-assembled, pre-greased and sealed unit. No additional seals are required. This enables faster and easier installation.
